## Fall 2015 CHES M Seminar

# **Risk Management & Insurance**

# Risk Control Techniques

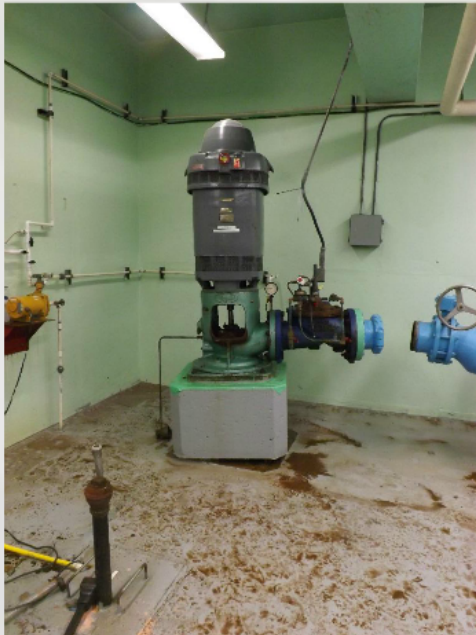
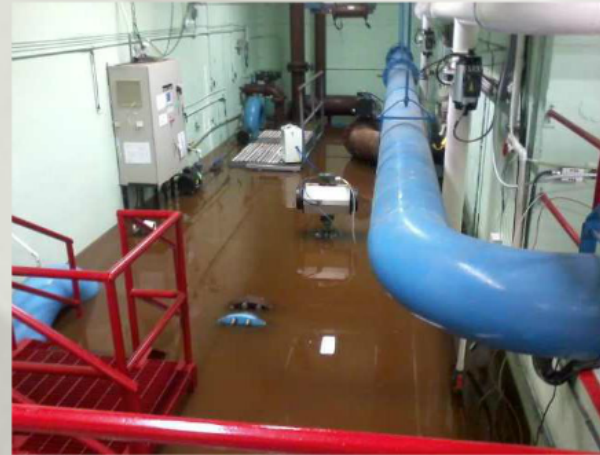
- Water treatment plant
- System drained and opened for maintenance on a valve
- Operators were unaware of connected systems affected by repair
- Main system put back in service with catastrophic failure of connected system

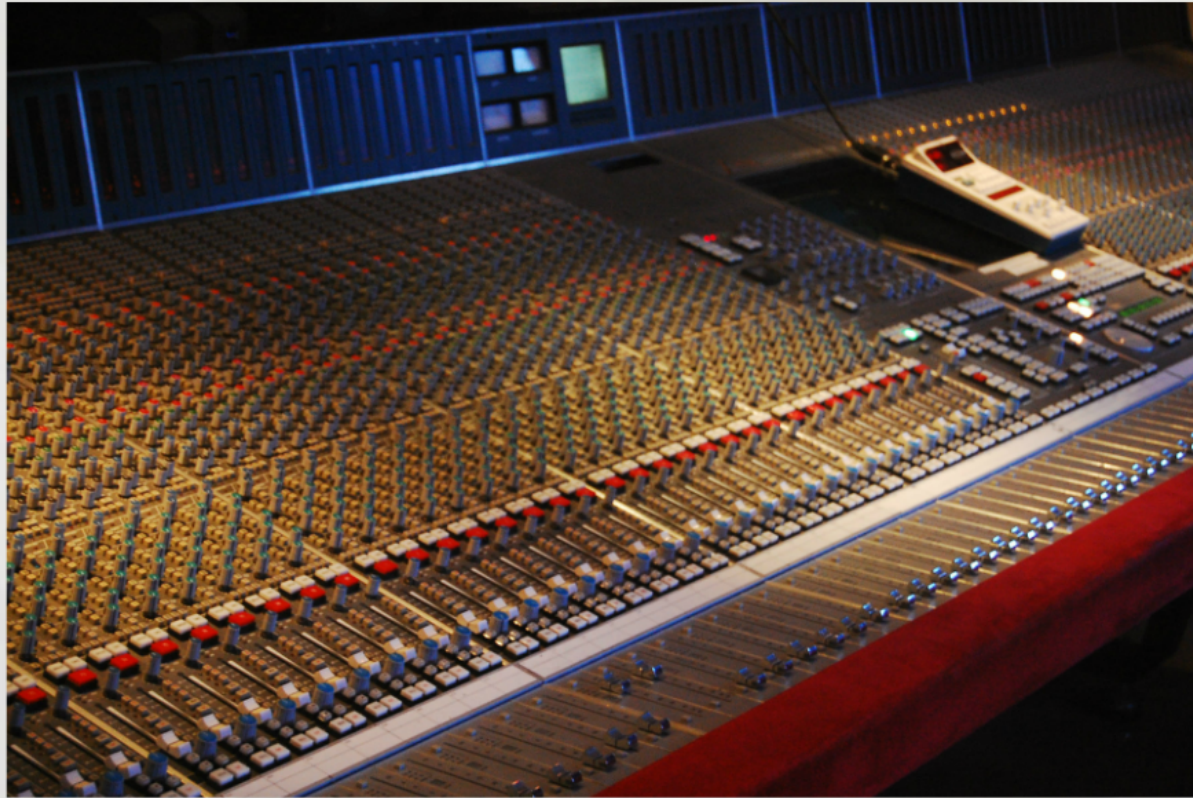
- Severe storm causes roofing damage to a sound studio
- Roofers brought in to apply new flat roofing
- They shut off power to roof mounted AC units to prevent fumes from entering building
- This turns off the dedicated AC to one of the sound studios mixing boards
- Mixing board overheats and 'melts'

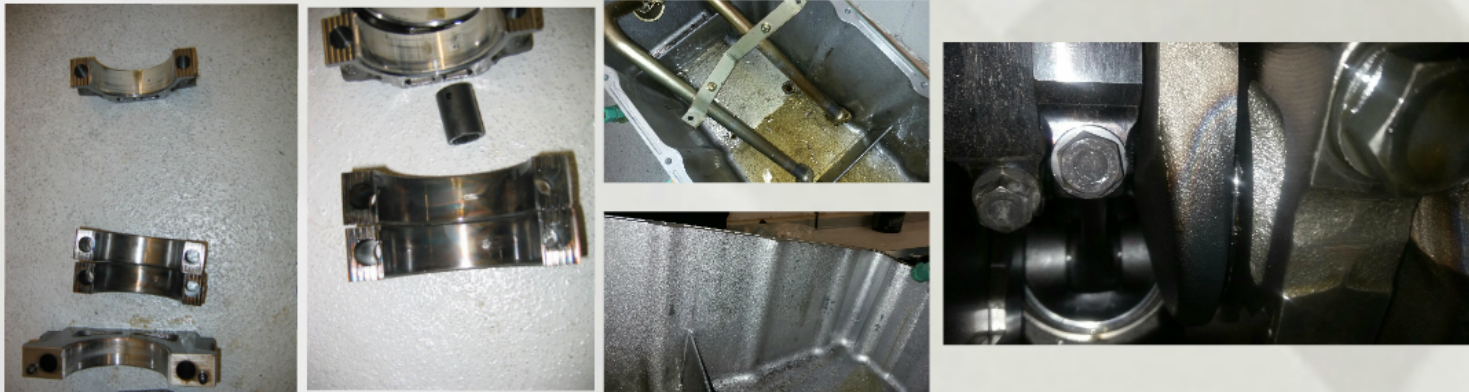
- Cleaning personnel assigned to start backup D.G as part of monthly P.M.
- Overlooks the puddle of oil beneath the engine prior to starting
- Either ignores or is absent to notice numerous alarms that trigger during engine run time
- Engine fails catastrophically

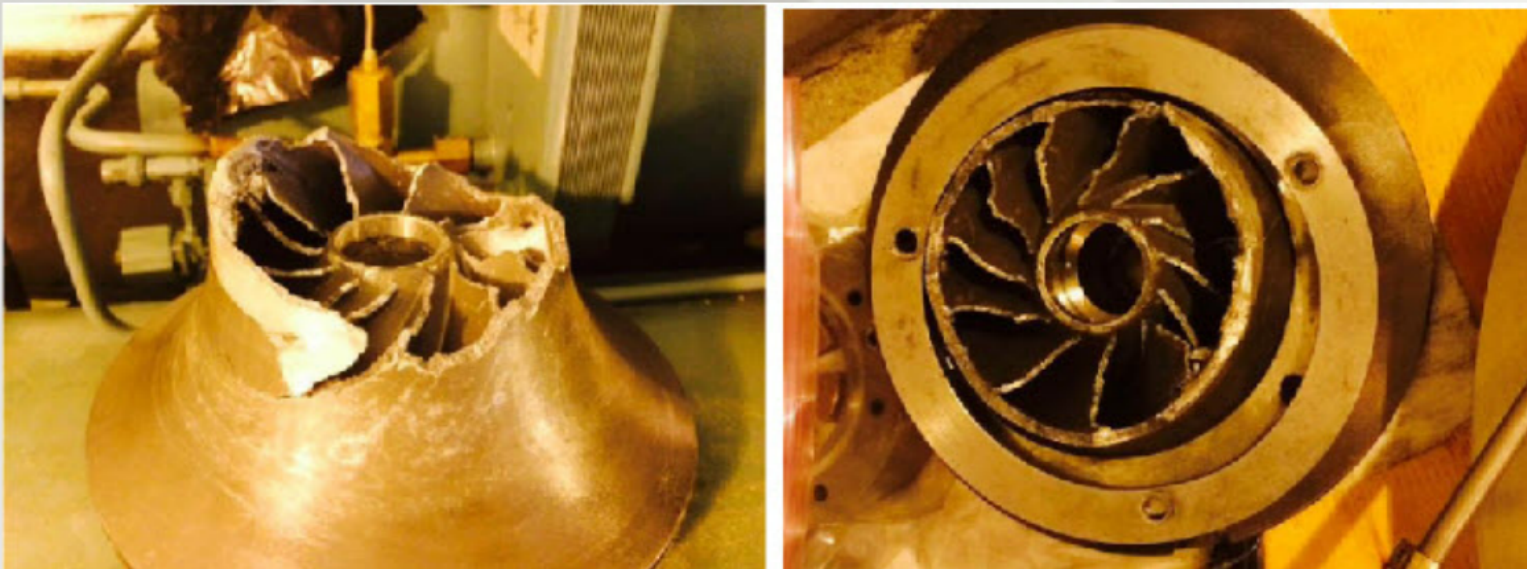
- Chiller trips off due to low oil pressure
- Maintenance company brought in to remedy
- Oil cut-out bypassed in order to diagnose problem
- Catastrophic failure of chiller ensues
- Further investigation determines oil pump had initially failed

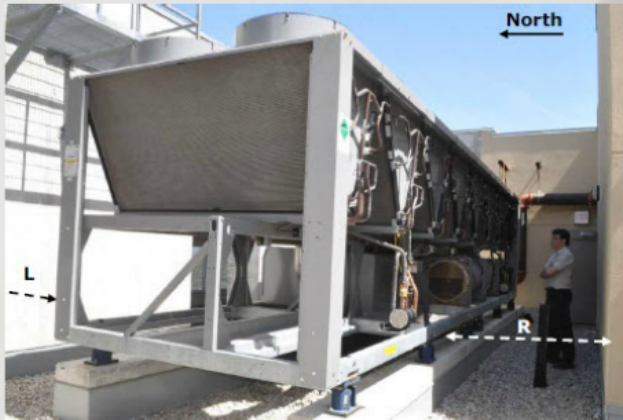
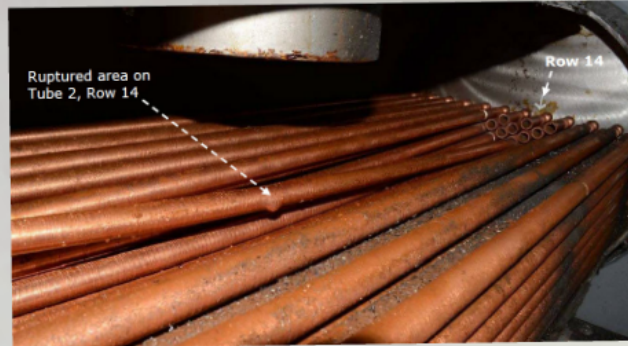
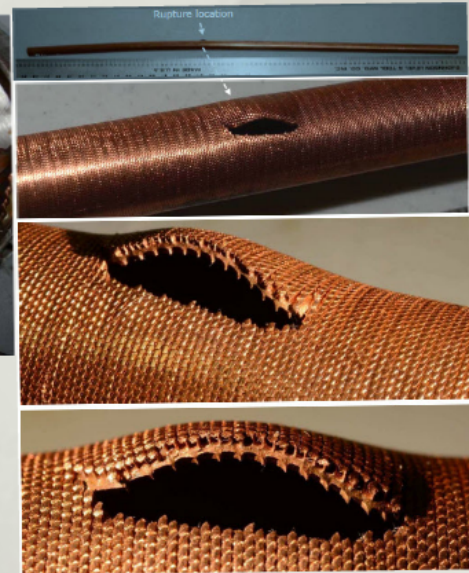
- Duplex rooftop chiller system
- Commissioning process not completed properly
- Antifreeze not added to system compounded the failure
